## The Tay Rail Bridge disaster revisited

T. Martin BSc and I. A. MacLeod BSc, PhD, FICE, F1StrcutE

**A view is being expressed that the Tay Rail Bridge disaster of 1879 was not fundamentally due to the action of the wind but was a result of fatigue damage caused by dynamic loading. The paper discusses this proposition and shows that the evidence to support it is weak.**

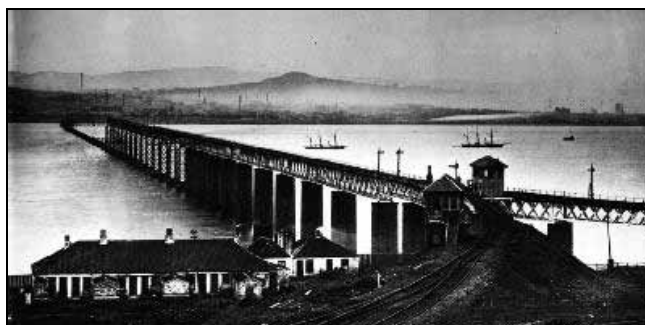
Fig. 1. Tay Rail Bridge after the collapse, looking from the south (courtesy of the University of St. Andrews)

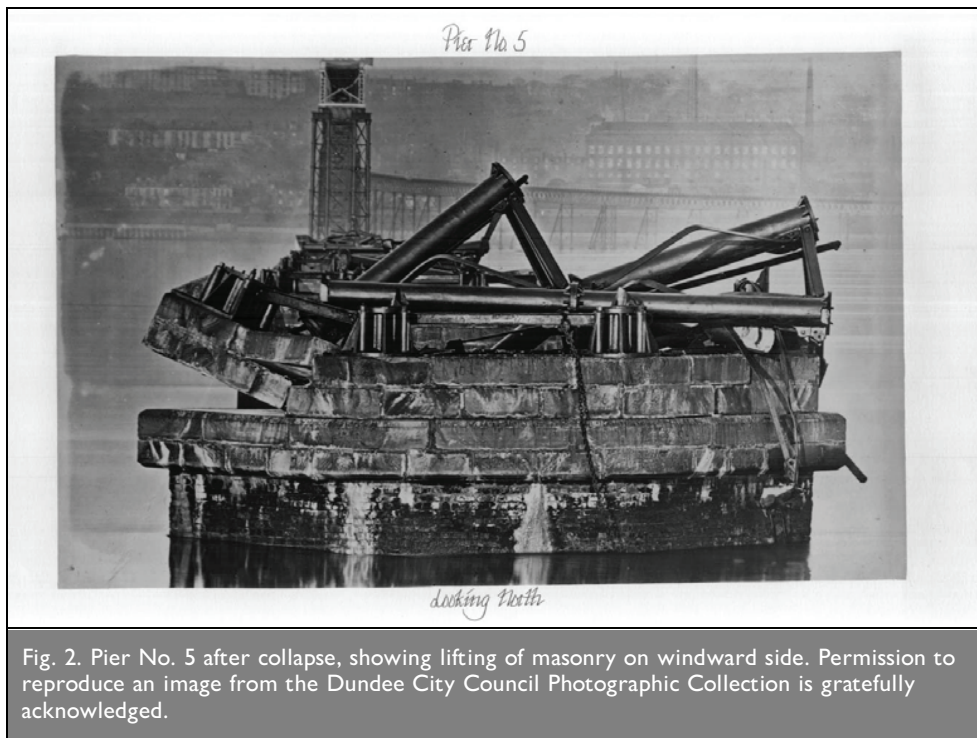
- As the columns were not properly anchored to their supports (the wind forces used by Bouch indicated that there would be no uplift) there was a tendency for the columns to lift on the windward side taking two courses of masonry with them. That they did lift in this way is clear from the photographs taken after the event (Fig. 2).
- This lifting preceded failure of the bracing ties.
- The lifting of the windward columns threw more load into the bracing for the same lateral load.
- The maximum bracing load was at the second level of bracing above the base. In some of the collapsed piers the lowest level of bracing survived.
- The force of the wind on the train provided a greater overturning effect than the weight of the train in resisting overturning. Therefore the worst condition for overturning was with the train on the bridge.

Fig. 2. Pier No. 5 after collapse, showing lifting of masonry on windward side. Permission to reproduce an image from the Dundee City Council Photographic Collection is gratefully acknowledged.

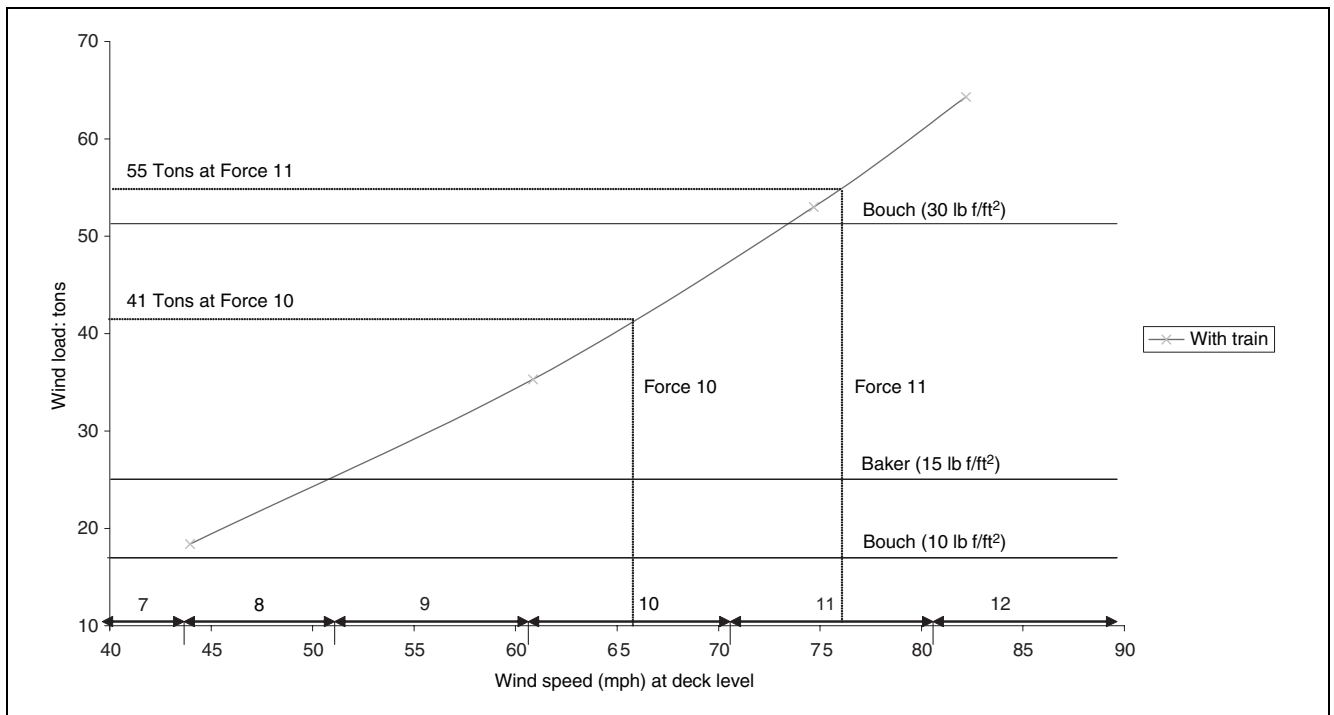
Fig. 3. Wind load in relation to wind speed (1 mph = 0.45 m/s; 1 ton force = 9.97 kN; 1 lb f/ft<sup>2</sup> = 47.880 N/m<sup>2</sup>)

A wind pressure of 15 lb f/ft<sup>2</sup> corresponds to a Beaufort force 8 whereas the estimated Beaufort value was force 10–11<sup>2,3,6–9,12</sup> (Fig. 3). The upper end of force 10 corresponds to a pressure on the bridge of 28 lb f/ft<sup>2</sup> and the upper end of force 11 to a pressure of 36 lb f/ft<sup>2</sup>.

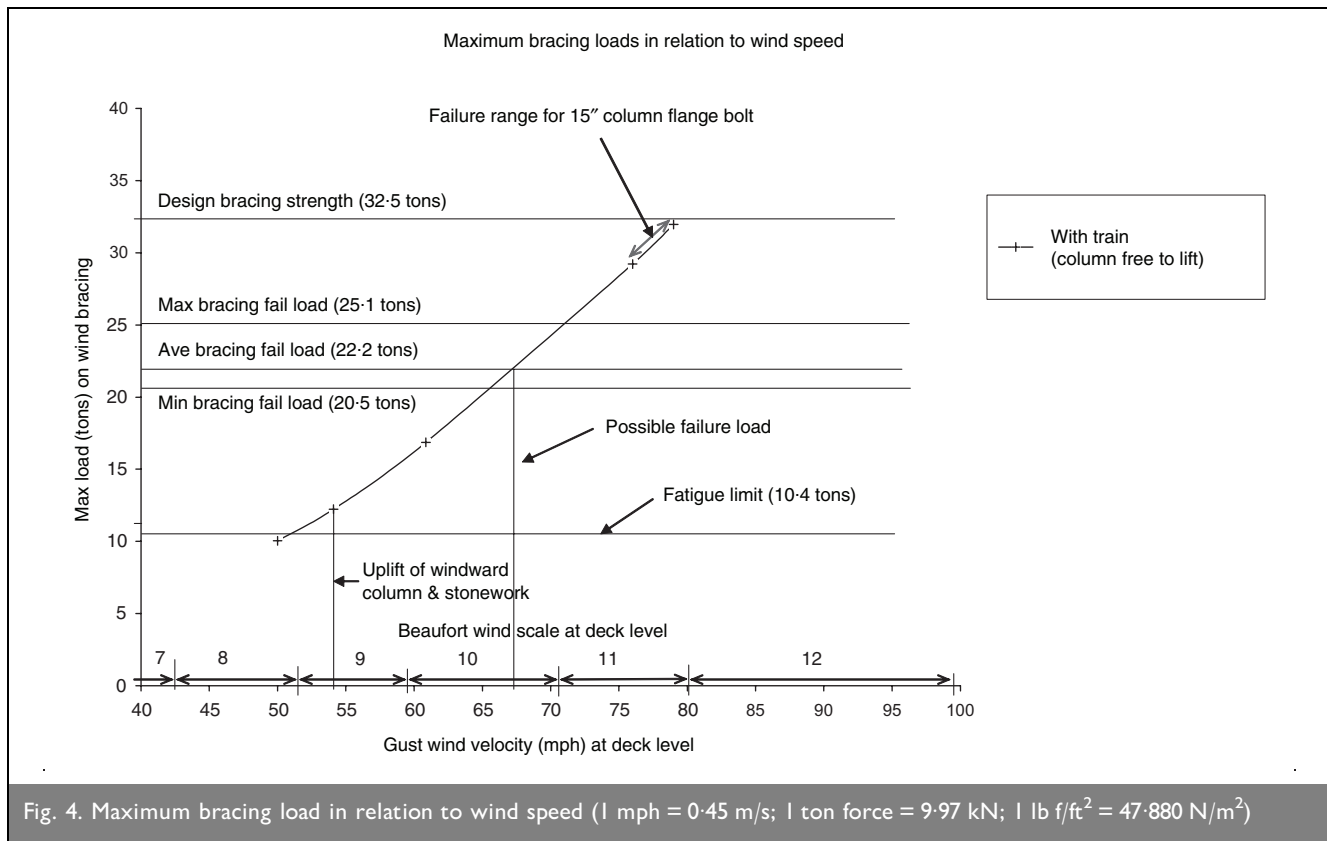
Fig. 4. Maximum bracing load in relation to wind speed (1 mph = 0.45 m/s; 1 ton force = 9.97 kN; 1 lb/ft<sup>2</sup> = 47.880 N/m<sup>2</sup>)

9 tons/in<sup>2</sup>. Fig. 4 shows that the wind strength required to reach the fatigue limit in the tie is about Beaufort force 8/9. Therefore it appears that the wind caused loading in the ties slightly above the fatigue limit on approximately 10 out of 1696 12-h periods (i.e. 0.6% of the total time) and only significantly exceeded the fatigue limit load on the night of the disaster.

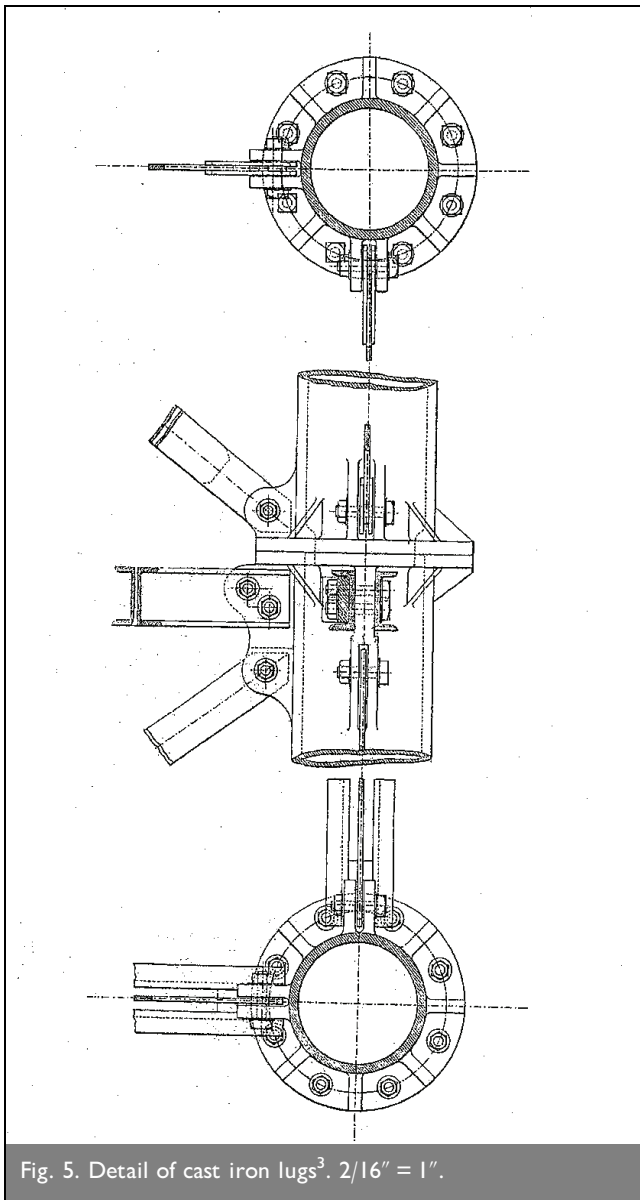
Observations from the wreckage<sup>3</sup> indicated that failure of the tie bar assembly occurred at the cast iron lugs in all cases. Fig. 5 shows the lug details.<sup>3</sup> An estimate of the strength of the lugs is 59 tons (1 ton = 4.44 kN) based on an ultimate stress of 9.0 ton/in<sup>2</sup> in the cast iron. This compares with the design strength of

Fig. 5. Detail of cast iron lugs<sup>3</sup>. 2/16" = 1".

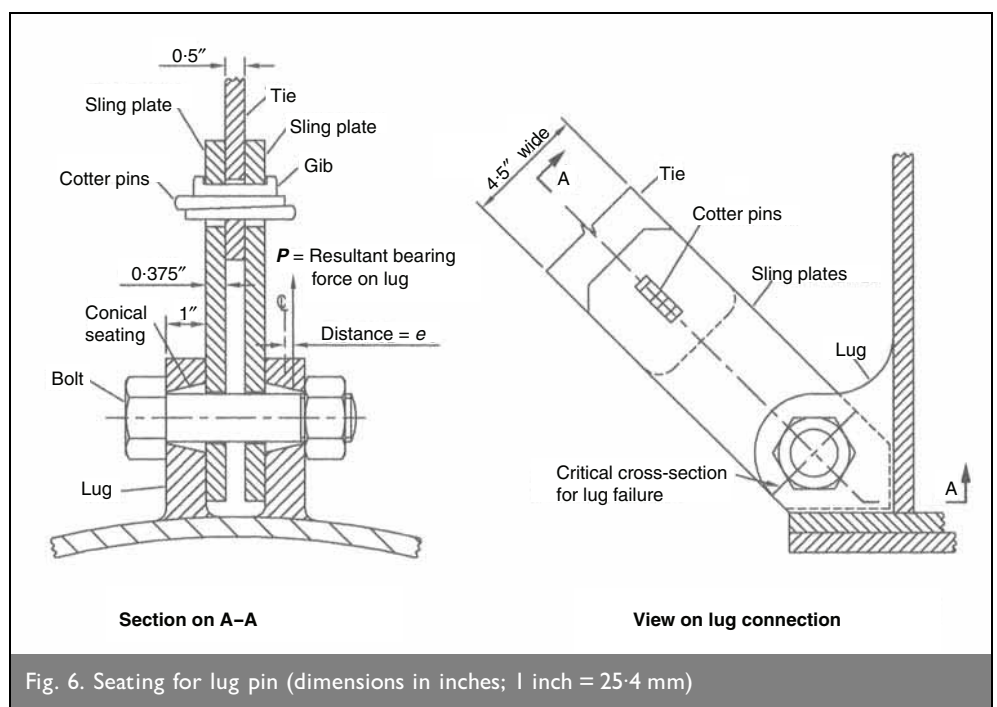
executed. The holes in the lugs were as cast and caused the bearing surface to be conical. This would cause the load on the lug to be eccentric resulting in a magnification of the axial stress in the lug due to bending. Fig. 6 shows the bearing of a pin on a lug with a conical bearing support resulting in an eccentricity ( $e$ ) relative to the central plane of the lug plate.

The actual magnification is  $59/22.2 = 2.67 = 1 + 6e/c$ . This corresponds to an  $e/c$  ratio of 0.28. The diameters of the holes in the lugs as cast varied from 1.125 in at the outside face of the lug to 1.25 in at the inside face of the lug. The taper was therefore significant and it is not difficult to imagine that an  $e/c$  ratio of 0.28 would have been achieved. The reduction in the measured strength of the lugs against the design strength may therefore be explained by the non-parallel bearing surfaces for the pins. In both the tests and in the examination of the wreckage there was no evidence of failure of the bolts which attached the sling plates to the cast-iron lugs although the bolts recovered from the wreckage were distorted. The conical seating is likely to have been a major cause of this distortion.

Fig. 6. Seating for lug pin (dimensions in inches; 1 inch = 25.4 mm)

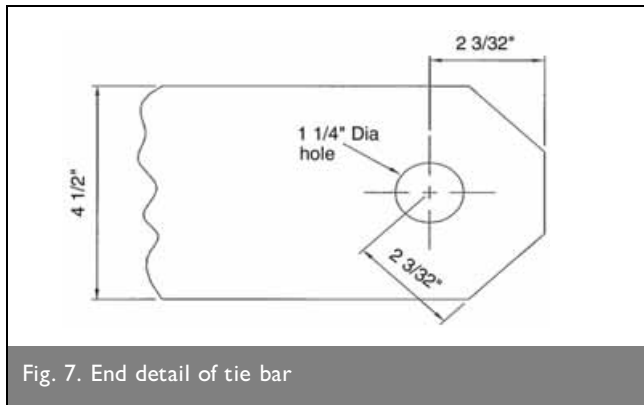
Fig. 7. End detail of tie bar

tie bar itself. Fig. 7 shows tie bar dimensions at the bolted end. The edge distances are within current code limits but the stress concentration due to the presence of the hole resulted in an average tie strength of 25.6 tons as compared with the design strength of 32.5 tons and the average lug strength of 22.2 tons.
