The Tay rail bridge disaster — a reappraisal based on modern analysis methods

T. Martin, BSc, and I. A. Macleod, BSc, PhD, FICE, FStructE

The collapse of the world's longest bridge in 1879 with the loss of 75 lives exposed a major weakness in British civil engineering. While American and French engineers were using significant wind loadings, few of their British counterparts even considered it. But there is still speculation as to exactly why the first Tay rail bridge in Scotland failed and as to whether its designer, Sir Thomas Bouch, was to blame. This paper, based on a recent three-dimensional computer analysis using a modern approach to wind loading, throws new light on the collapse.

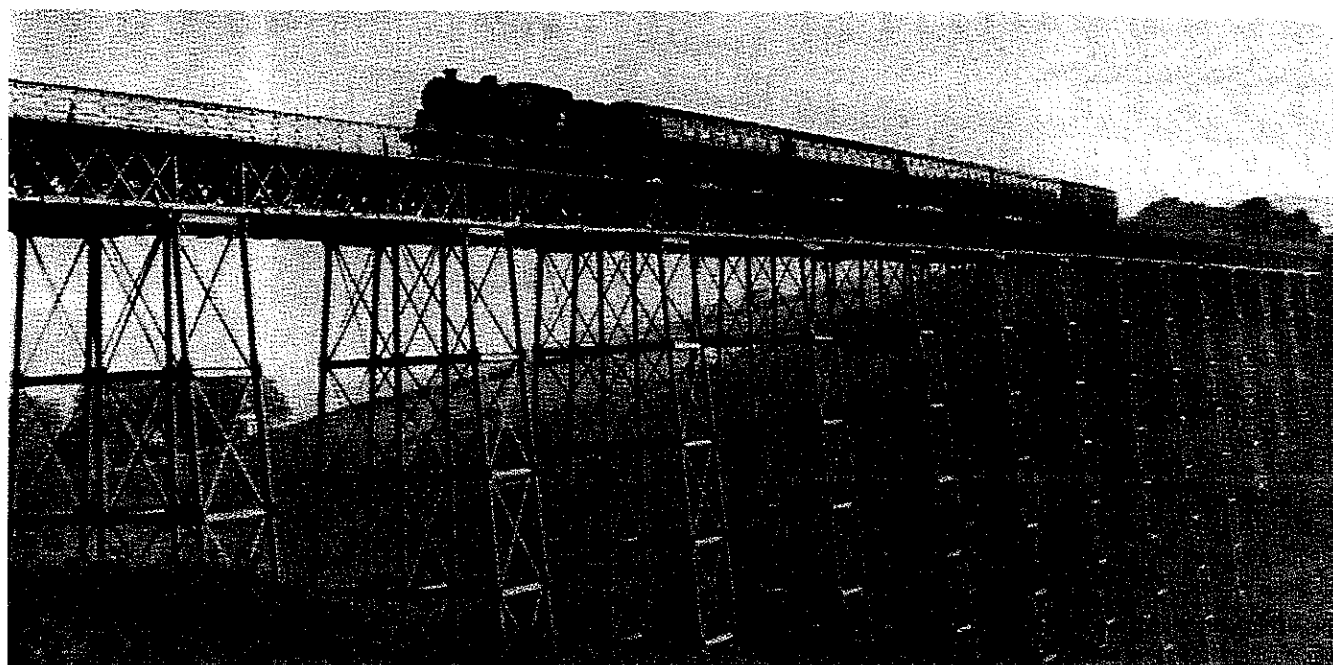
Fig. 3. Belah Viaduct, 1858

A key insight into the human cause behind the technical cause for the collapse of the bridge can be gained by comparing the design of the Belah Viaduct (Fig. 3) with the Tay Bridge. It is difficult to comprehend that both structures were designed by the same engineer. The court of inquiry in comparing the two structures reported

Bouch was questioned by Barlow (designer of the present Tay rail bridge) why he deviated from the plan he had adopted in the Belah Viaduct for the horizontal ties. His answer that

They were so much more expensive; this was a saving of money

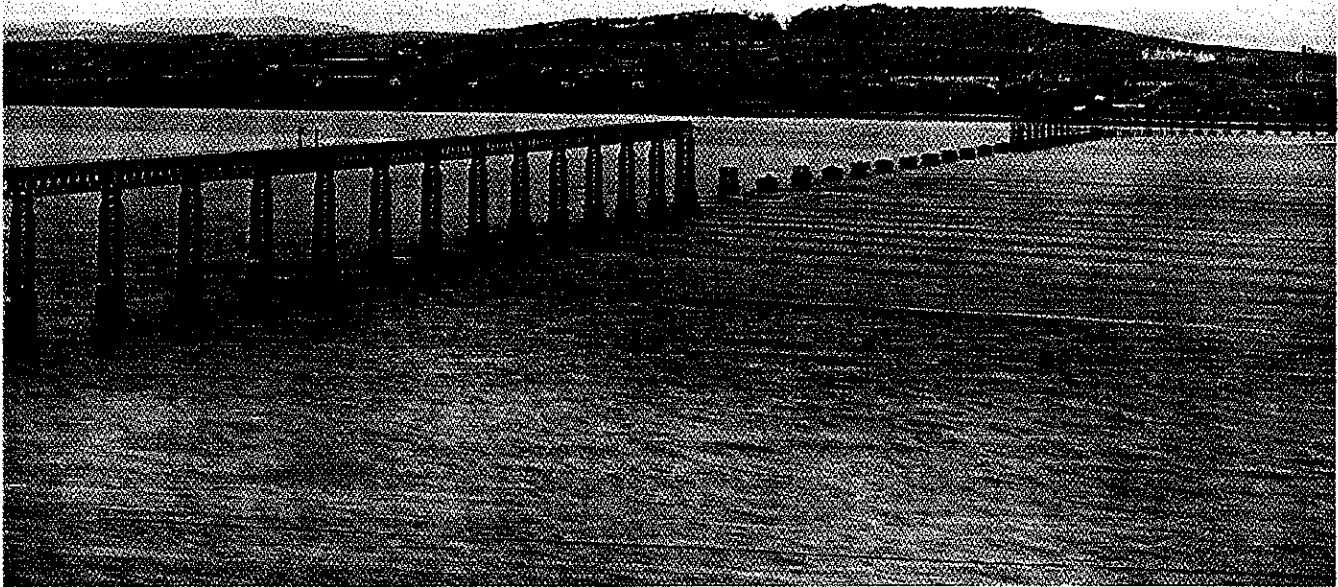
Fig. 4. Tay rail bridge after 1878 collapse (viewed from south)

The disaster occurred on the stormy night of 28 December 1879. A train of one engine and six carriages crossing the bridge from the south to north was lost when the structure of the navigation spans section collapsed (Fig. 4). Detailed accounts of the disaster are given by Thomas¹ and Prebble². There were no survivors from the 75 people aboard the train. The gale blowing along the Tay estuary at right angles to the bridge was estimated at force 10 to 11 on the Beaufort Scale by local naval officers. Local amateur meteorologists also reported that the train was crossing the bridge about the time the gale was at its peak.³

An examination of the ruins of pier No. 32, being that over which the train was situated when the structure fell, indicates that the columns doubled up about their joints as the lower lengths of the westward 15-inch columns were pushed over to the west, or in the reverse direction to that in which the rest of the structure fell. A similar action in pushing back the westward columns is seen in piers Nos. 36, 39 and 40.

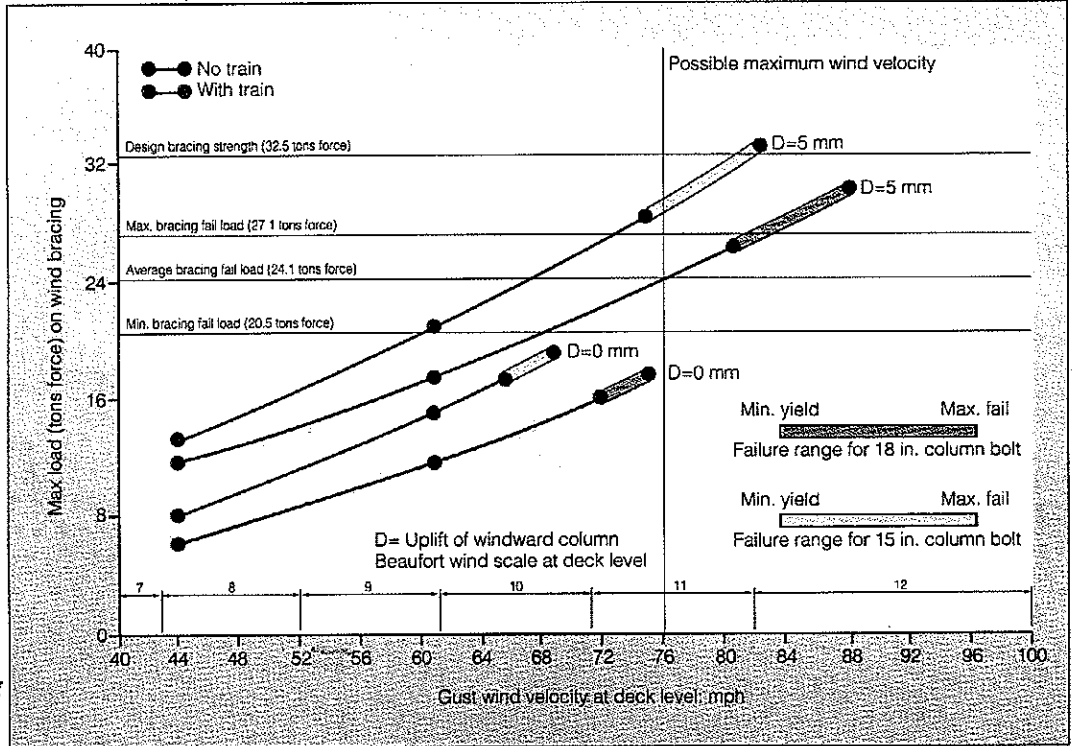
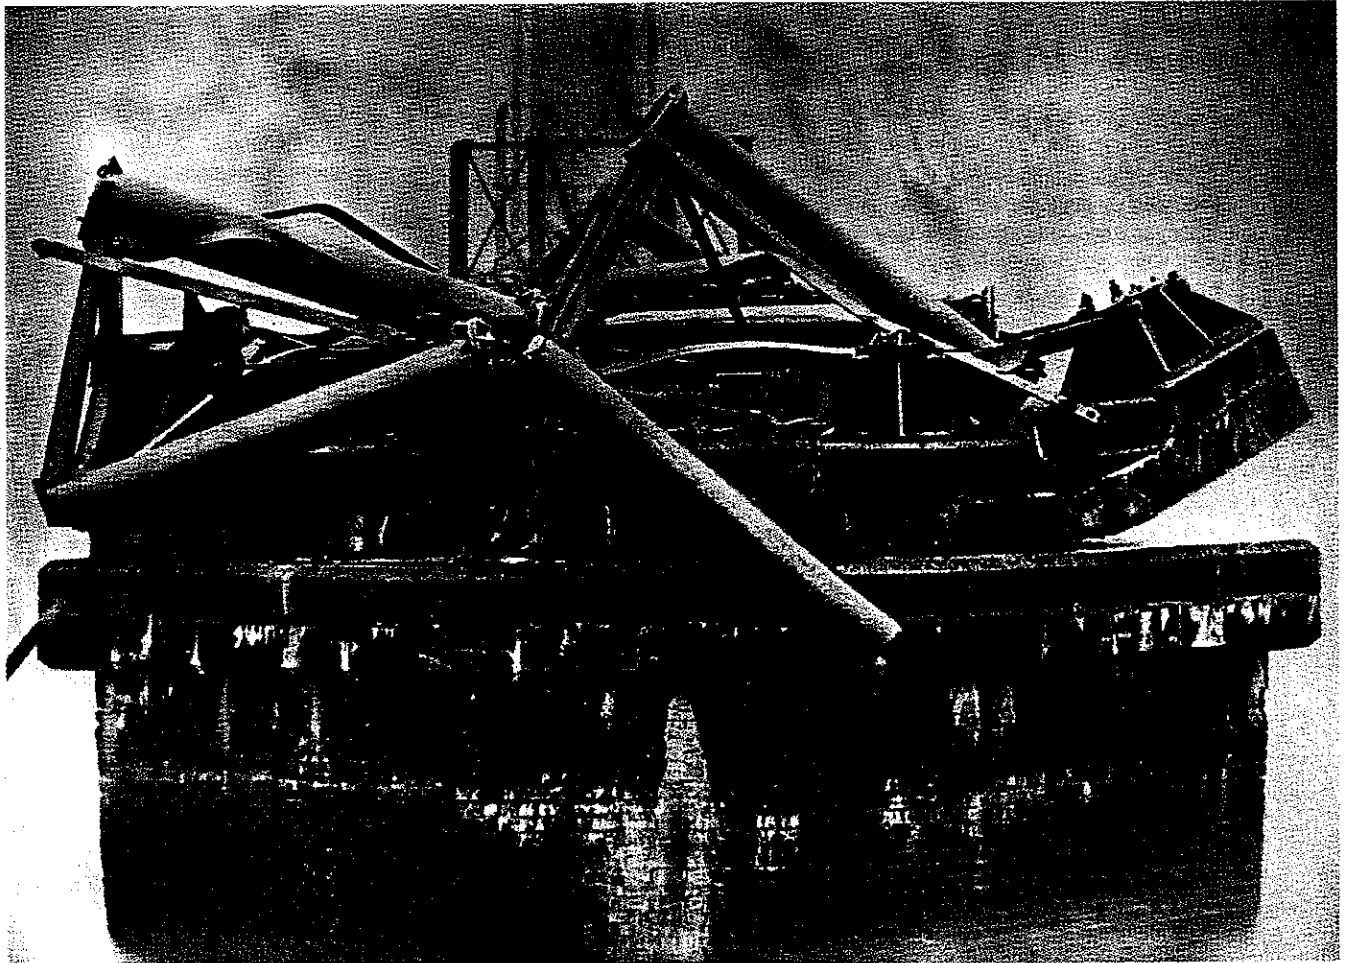
Fig. 6. Maximum bracing loads in relation to wind speed
(1 mile/h = 0.45 m/s,
1 ton force = 9.97 kN)

Fig. 6 shows the predictions of behaviour. The main variables considered in the analysis were as follows.

- *Whether or not the train was on the bridge* — the train appears to have had a significant effect on the overturning action.
- *Tensile failure of the column baseplate bolts* — these bolts were not expected to be in tension but Fig. 6 shows that failure could have occurred under force 10 conditions with no uplift.

- *Uplift of the windward column base* — this factor was not considered at the time of the original inquiry⁶ but it does have a significant effect on the bracing load. It is likely that this was the first step in the collapse. The 5 mm uplift used in Fig. 6 is based on an estimated weight of foundation resisting the applied load at a wind speed of 34 m/s (with no vertical restraint at the column base in the analytical model). Such a lift moves the likely column

- baseplate bolt failure to the next row of columns. The windward columns failed in bending just above the baseplates.
- *Bracing strength* — the design strength of a bracing member in tension was 32.5 tons force (1 ton force = 9.97 kN) but measured strengths were less than this as shown in Fig. 6. The uplift of the windward columns significantly increases the bracing load. An important observation from the analytical results is that the

highest bracing load is not at the level above the base of the columns but at the next level up. This is due to the fact that the moment connection at the base of the column induces the column to take some of the base shear thus relieving the bracing load at the base.

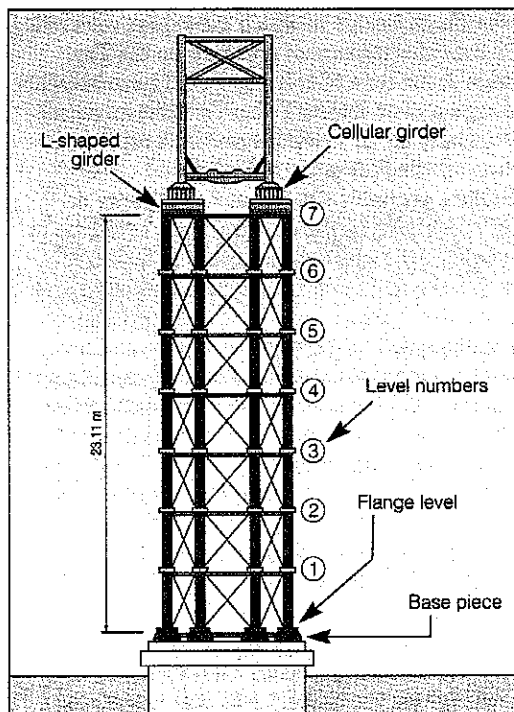
Fig. 8. Elevation of a typical navigation span pier.

On the basis of these observations a scenario for the collapse is as follows. When the train reached the high girders there was a particularly strong gust. The presence of the train increased the overturning effect marginally and the bolts in the windward columns of the piers came into tension. Because they were intended for location purposes rather than to take tension they were not fully anchored into the masonry of the pier. The column bases started to lift off taking two courses of masonry with them (Fig. 7). This had the beneficial effect of reducing the loads in the baseplate bolts but caused a significant increase in the diagonal bracing members causing them to fail. These members first failed not at the bottom level but at a level above that. This triggered a toppling collapse with rotation tending to be at level 1 (Fig. 8). During the process of toppling there was a kickback to windward on the remains of the piers below level 1.

suggests that Bouch may have compromised the strength and stability of the redesigned piers because the project was well over budget and behind schedule. This view is corroborated by the fact that Bouch had intended to use eight columns in rows of two (similar to the Belah Viaduct) instead of six columns in the shape of a hexagon.¹ Most engineers would feel empathy for his predicament. If the funding of the project had been more favourable it is likely that a stronger, more stable pier structure would have been built.
