The Tay rail bridge disaster — a reappraisal based on modern analysis methods

T. Martin, BSc, and I. A. Macleod, BSc, PhD, FICE, FStructE

The collapse of the world's longest bridge in 1879 with the loss of 75 lives exposed a major weakness in British civil engineering. While American and French engineers were using significant wind loadings, few of their British counterparts even considered it. But there is still speculation as to exactly why the first Tay rail bridge in Scotland failed and as to whether its designer, Sir Thomas Bouch, was to blame. This paper, based on a recent three-dimensional computer analysis using a modern approach to wind loading, throws new light on the collapse.

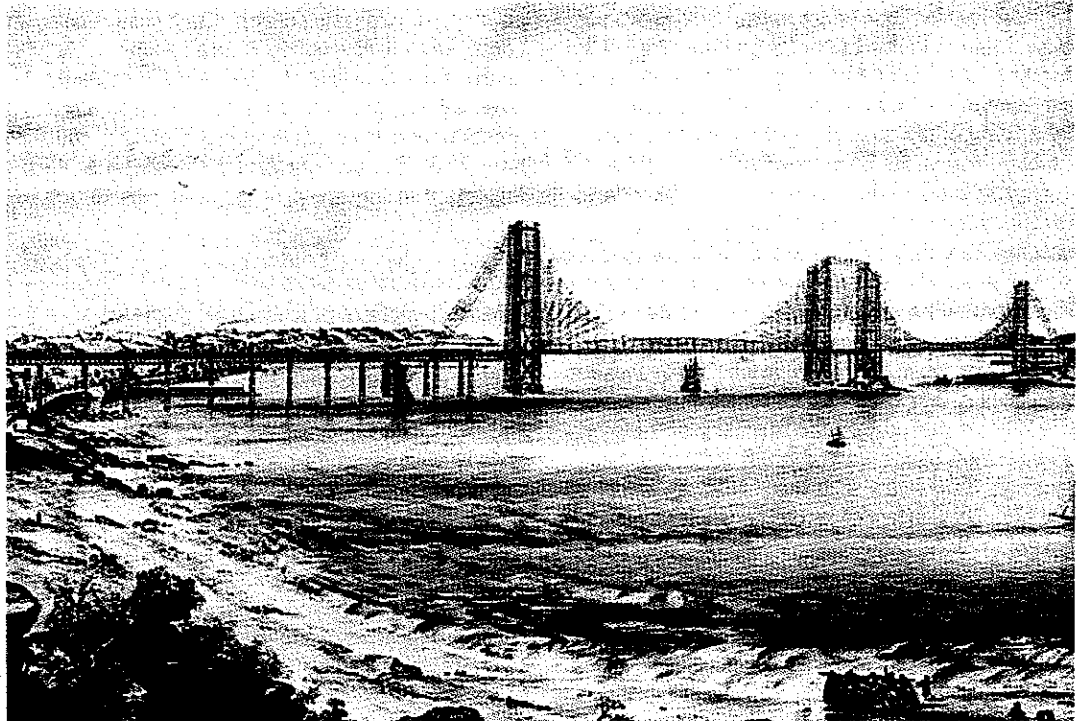
*Fig. 9. Bouch's design
for the Forth rail
bridge prior to the
Tay collapse*

At the time Bouch redesigned the piers for the Tay Bridge he was also working on the design of the proposed Forth rail bridge (Fig. 9). Because of the magnitude of the spans (488 m) he consulted some eminent engineers of his day (Hawkshaw, Bidder, Pole, Harrison and Barlow) on the question of wind pressure. These engineers in turn, not being satisfied with their judgement, consulted the Astronomer Royal, Sir George Airy. He reported that despite gusts of up to 40 lbf/ft² (1 lbf/ft² = 0.048 kN/m²) acting over 'very limited areas', an average pressure of 10 lbf/ft² acting over the whole length of the bridge was sufficient. This opinion was endorsed by the engineers, who considered the report highly authoritative.
